PHOTO SERIES NO. 24

PROCESSING TURKEYS, CALIFORNIA

OCTOBER 1958

Efficient handling, scrupulous cleanliness, and a wholesome ready-to-cook product attractively packaged--these are contributions of modern poultry processing plants to the American dinner table. In California's San Joaquin Valley, a leading turkey-producing area, numerous plants large and small operate several months during the year, processing and freezing turkeys, chickens and other poultry. These scenes are in a Modesto (Stanislaus County) plant which processes from 100,000 to 125,000 pounds of turkeys in an 8-hour day. Pictures were taken for USDA's Agricultural Marketing Service.

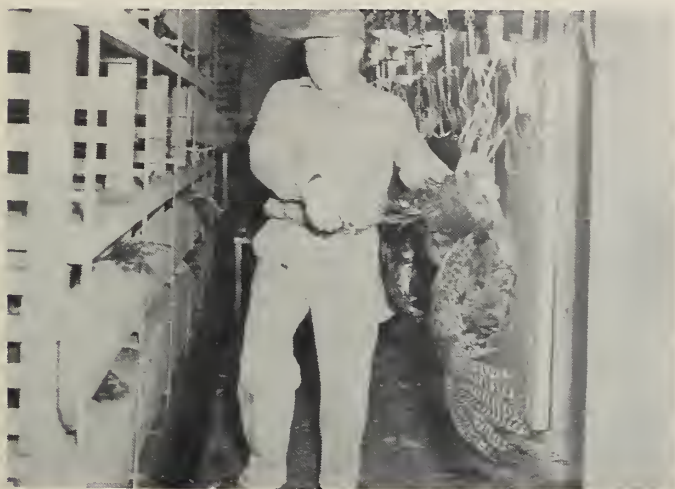
N-27969--Live turkeys are lifted from crates and placed on line.

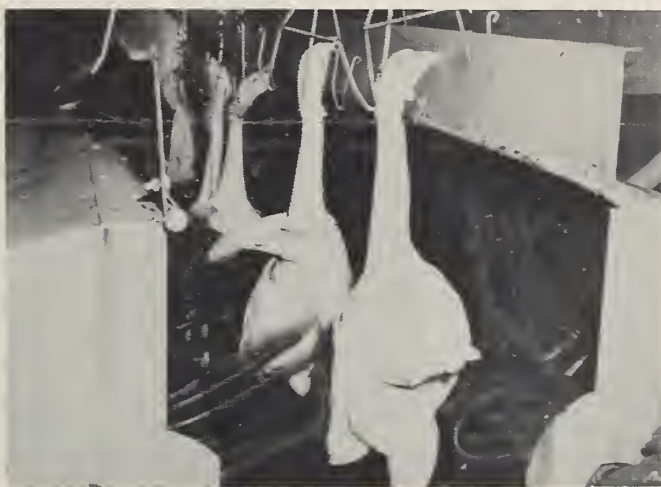
N-27965--After killing and scalding, turkeys go through rotary picker, then drop automatically into slant drum picker.

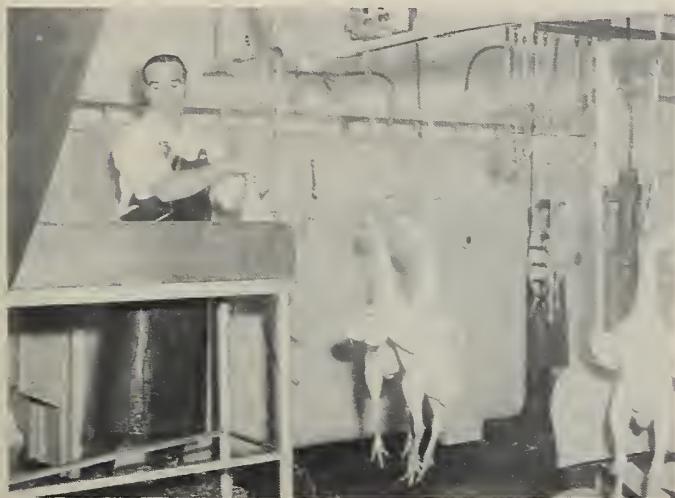
N-27968--After going through scalding and picking machines, turkeys are placed on slowly-moving line.

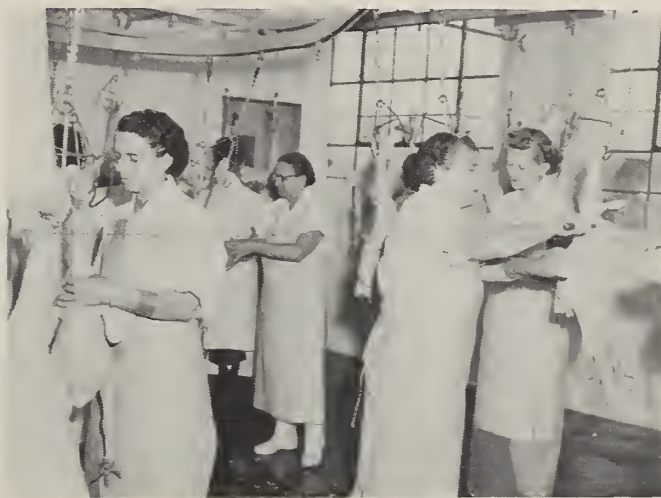
N-27966--After the birds go through the mechanical pickers, remaining pin-feathers must be removed individually.

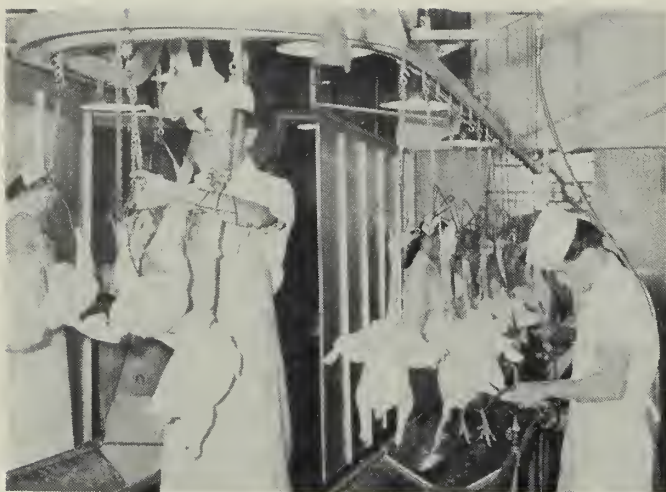
N-27964--Turkeys go through washer, then legs are cut off (right) and the birds placed in "3-point suspension" (left).

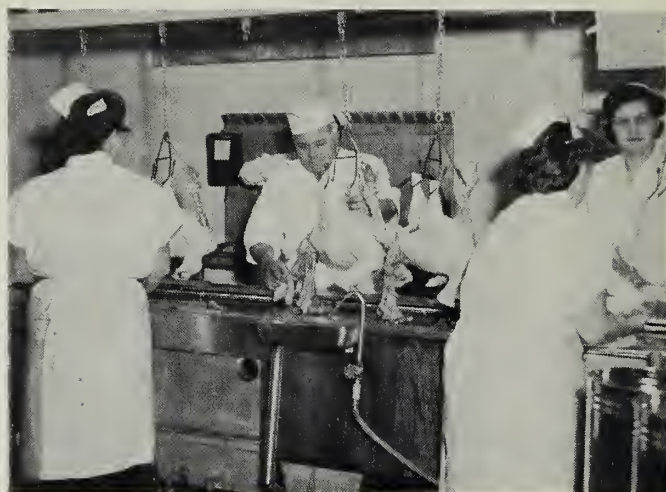
N-27960--Internal organs of each turkey receive thorough scrutiny of USDA inspector to insure wholesomeness.

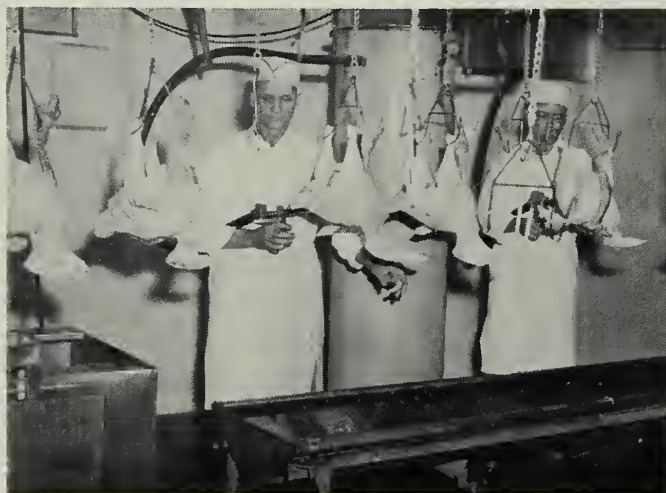
N-27958--On eviscerating line, lungs and kidneys are removed by vacuum.

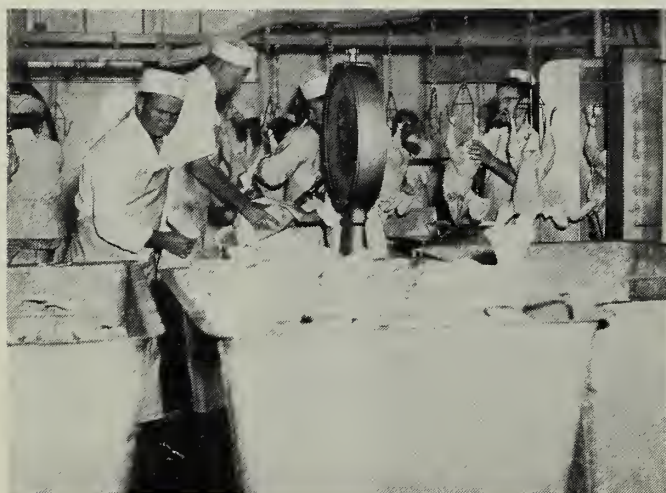
N-27957--After moving through final wash, turkeys are graded by USDA grader, sized and placed in appropriate chill tanks.

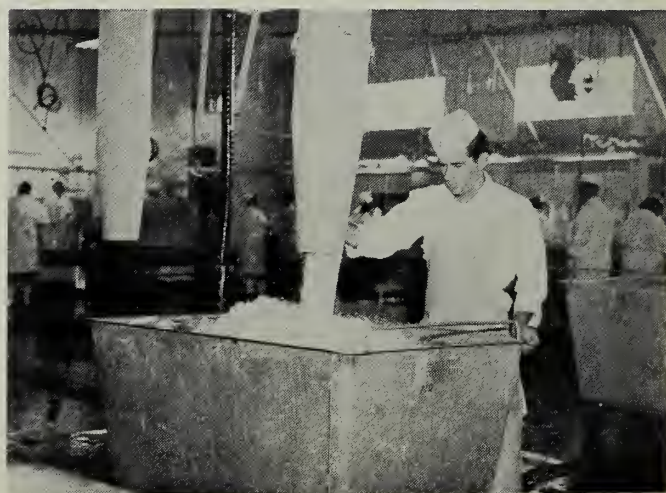
N-27978--Crushed ice is added to eviscerated turkeys in chill tank. They will cool overnight before being packed.

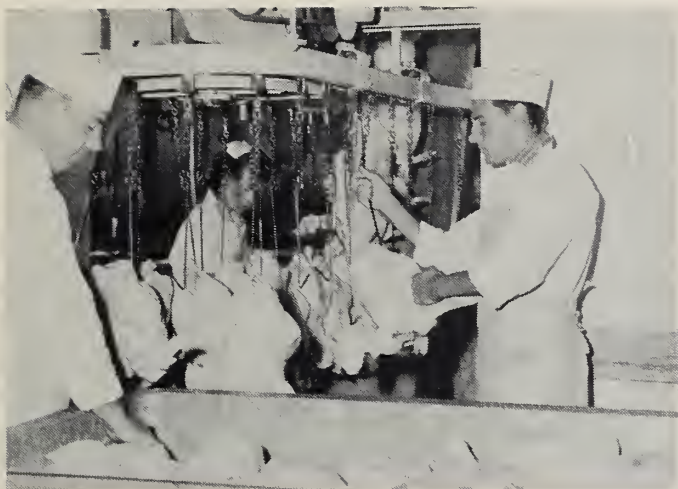
N-27974--From chill tanks where they have cooled overnight, turkeys are removed and placed on drainage line.

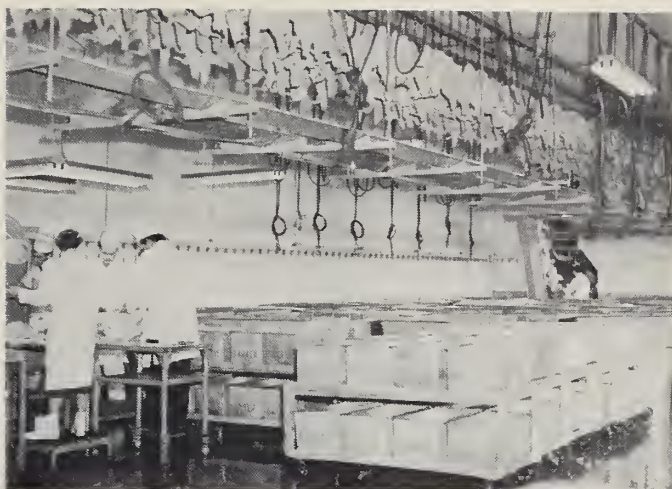
N-27983--Turkeys on drainage line. Stretching out of neck skin facilitates draining away of water.

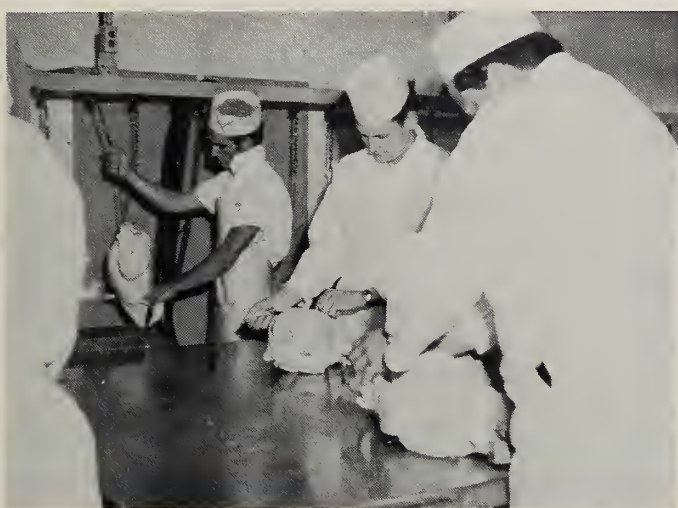
N-27987--Turkeys are taken from drainage line, legs tucked under skin strap, giblets inserted.

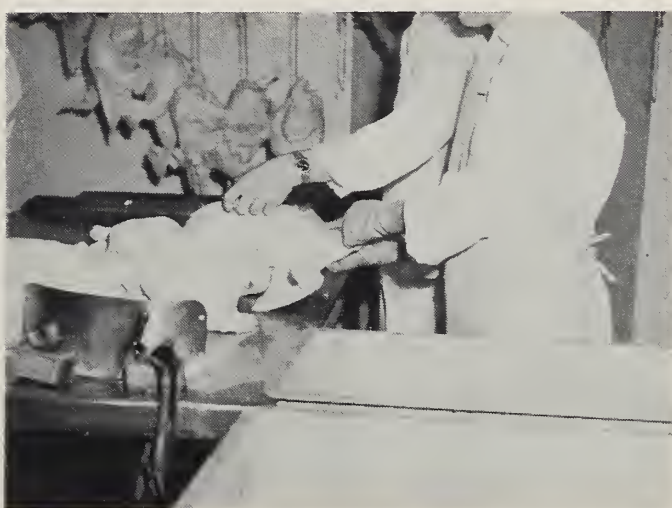
N-27986--Wrapped, chilled giblets being placed in crop cavity. Neck is already in body cavity.

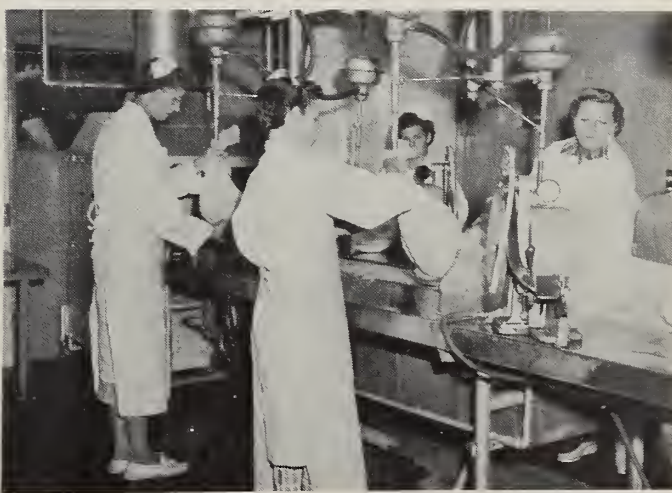
N-27984--Vacuum lifter sucks air from bag, which then is twirled and held closed with metal clip.

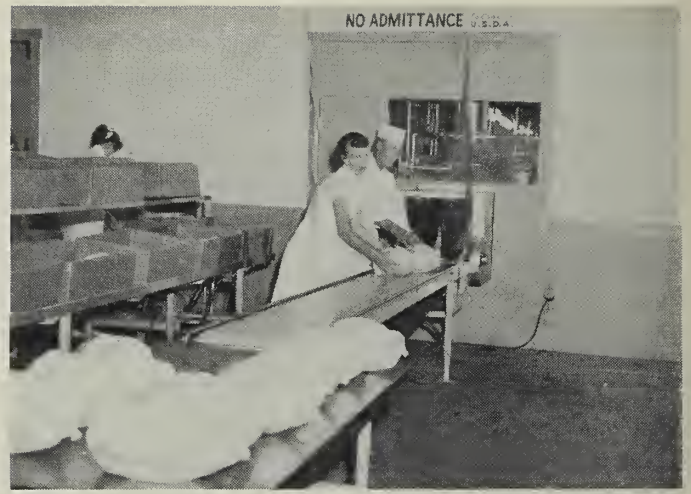
N-27980--Emerging from bag shrinker, packaged turkeys are packed by weight classes and weights are tallied by grade and size.

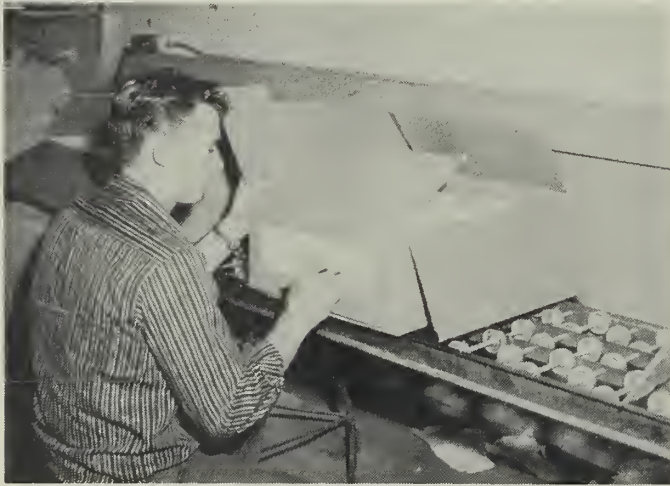
N-27970--Worker marks net weight of turkeys (from adding machine tape inside lid) on outside of carton.

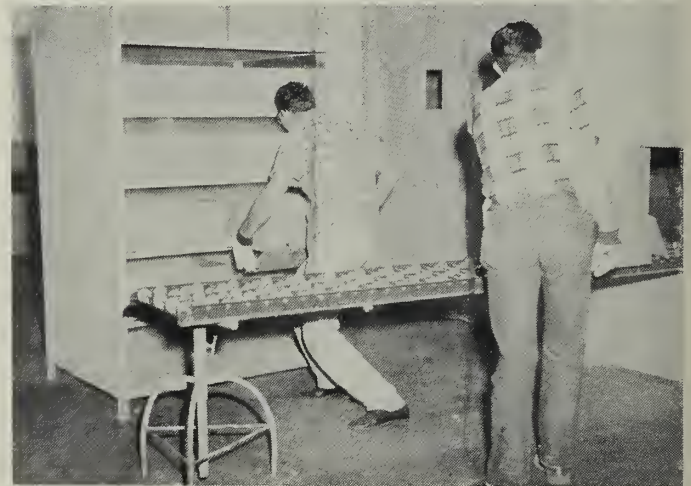
N-27971--Cartons of turkeys, lids open for more efficient freezing, are placed on racks then moved to freezing chamber for 18 to 24 hours.

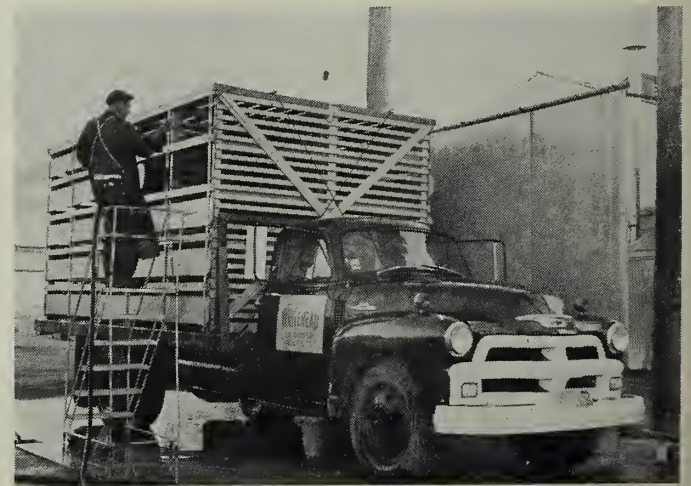
N-27976--Sanitary measures extend even to the hauling crates for turkeys, which are thoroughly cleansed prior to re-use.
